TREATMENT OF FROST AND MOISTURE SUSCEPTIBLE AGGREGATE IN NORTHERN MINNESOTA

Graded road treatment cuts costs

Stabilizer and geotextile strengthen Lake of
the Woods County road in Minnesota.

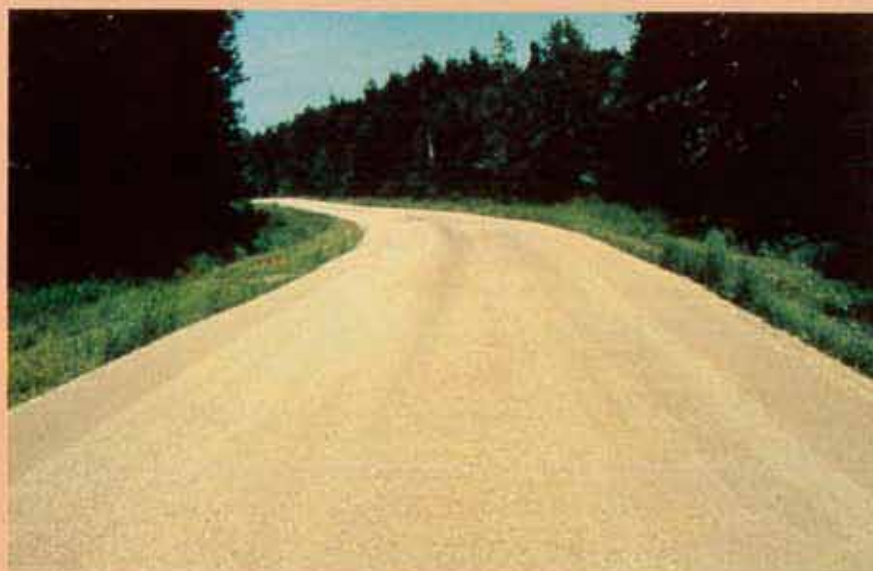
Photo shows the North West Angle Road in Minnesota. Even though the road is located in a wet, wooded area, use of liquid stabilizer reduced grading time and costs.

ta, 6 mi. of the newly placed gravel surfacing was treated with the stabilizer to a 3-in. depth by the county road maintenance crew. The liquid stabilizer solution was blade mixed with the gravel during application. The treated gravel mixture was then graded to shape and compacted with a steel drum vibratory roller.

While other gravel roads in Lake of the Woods County continued to suffer severe frost boils and a need for constant grading maintenance, the 6-mi. length of stabilized pit run surfacing performed through the fall, winter, and spring seasons without frost boils, soft spots, or potholes.
