Stabilized Aggregate Running Surface
in Service For Over Twenty Years

FHWA CTIP Study

STABILIZED AGGREGATE RUNNING SURFACES

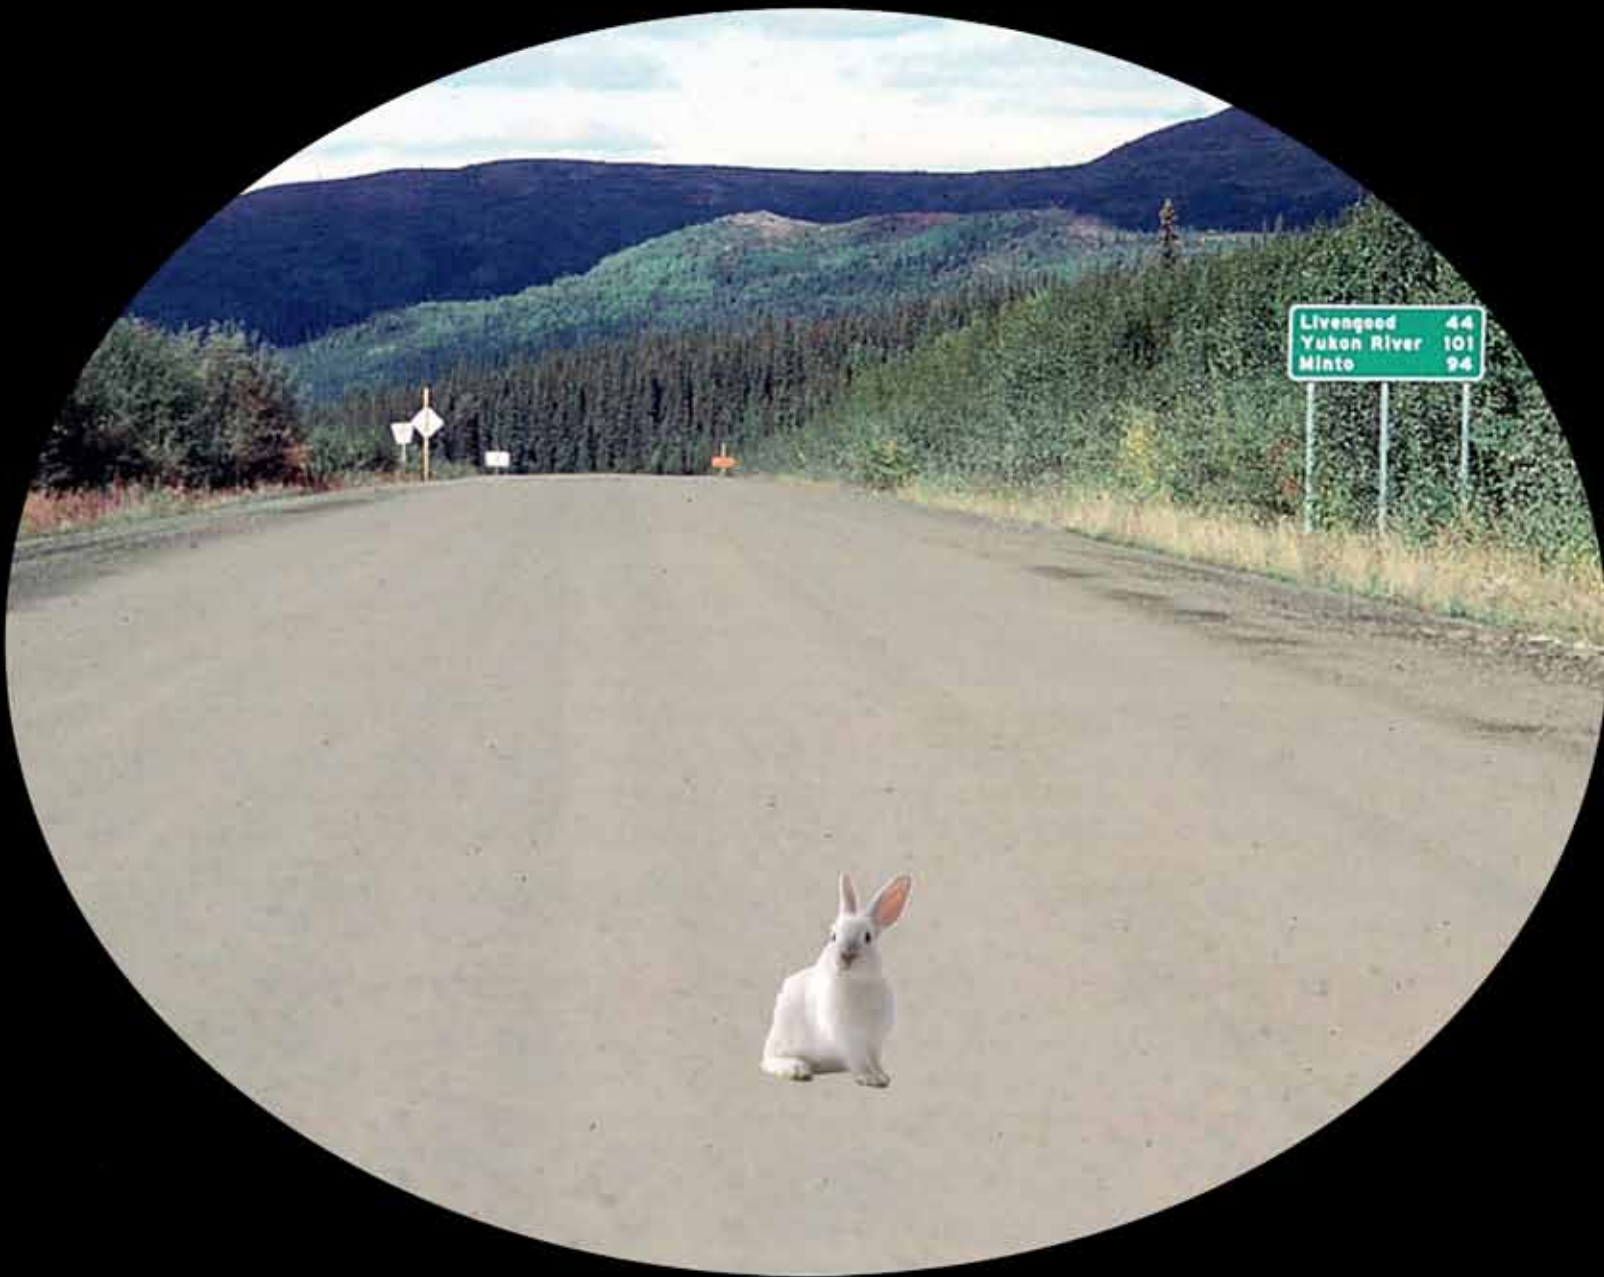
US Forest Service Road in Arkansas

Pictured here is a section of stabilized road constructed by a U.S. Forest Service road maintenance crew in the mountains of Arkansas as part of the CTIP Study. The aggregate mixture was treated with the EMC SQUARED Stabilizer, the concentrated liquid product developed by Soil Stabilization Products Company as an alternative to dust palliative products and cement and lime chemicals. Supplied as a liquid concentrate, this stabilizer product is diluted with water for application to soil, gravel and recycled pavement materials as part of standard road construction operations. The Forest Road Engineer for this CTIP Project in Arkansas provided a written report documenting the performance of the stabilized surfacing on this logging road. He confirmed that the stabilized surfacing was nearly maintenance-free after nine years in service. He later reported that the stabilized surface was still functional and low-maintenance after 20 years in service.

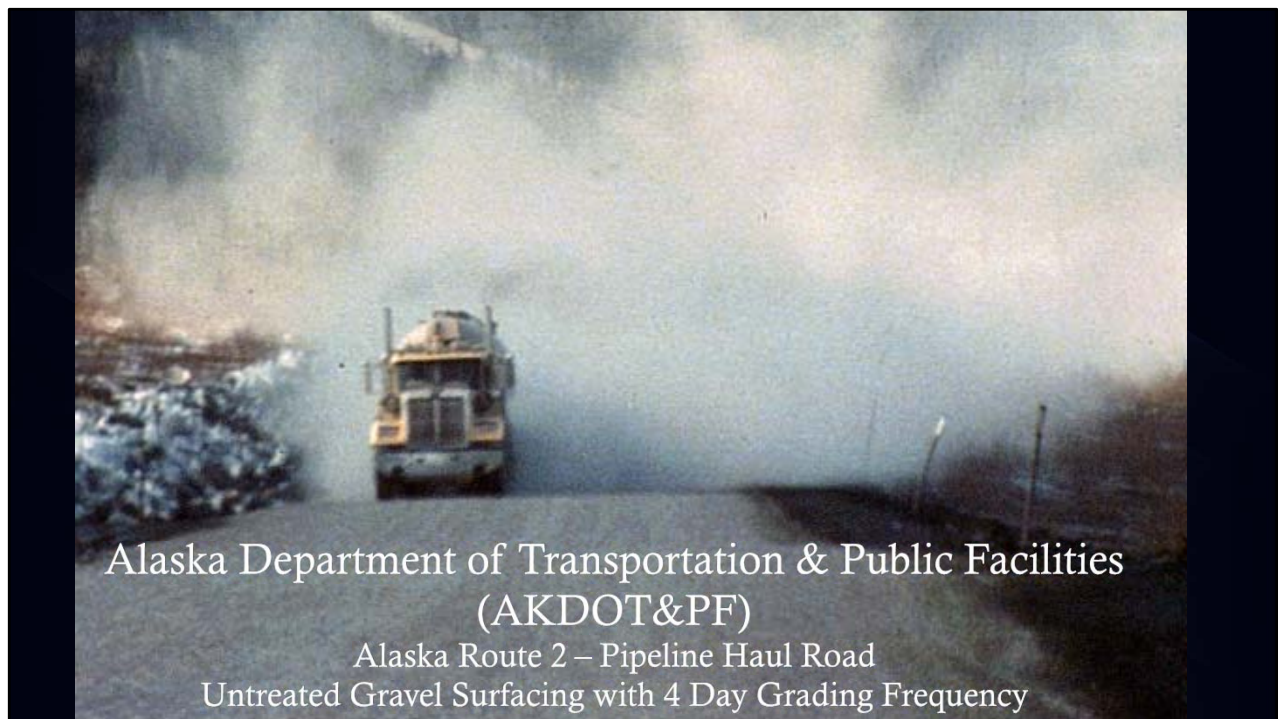
REMEDY FOR DUST EMISSIONS AND GRAVEL LOSS ON ALASKA ROUTE 2

Pictured here is a haul truck southbound from Prudhoe Bay driving on a section of Alaska Route 2, also known as the Dalton Highway and the Pipeline Haul Road, that was not stabilized or recently treated with a dust palliative. Grading of untreated gravel surfacing by the State maintenance crews was required once every four days, and almost immediately, following any significant amount of rainfall. The State Maintenance Superintendent had been observing the outstanding results of a liquid stabilizer product supplied by Soil Stabilization Products Company to ARCO and SOHIO, the companies originally operating the Prudhoe Bay oil fields. The State received funding from FHWA to conduct an Experimental Feature Project focusing on alternatives to the use of dust palliative products. The State then evaluated the performance of the EMC SQUARED Stabilizer product in comparison with a calcium chloride dust palliative application. The State of Alaska reported that the cost to stabilize six-inches of aggregate was less than the cost for their annual calcium chloride application.

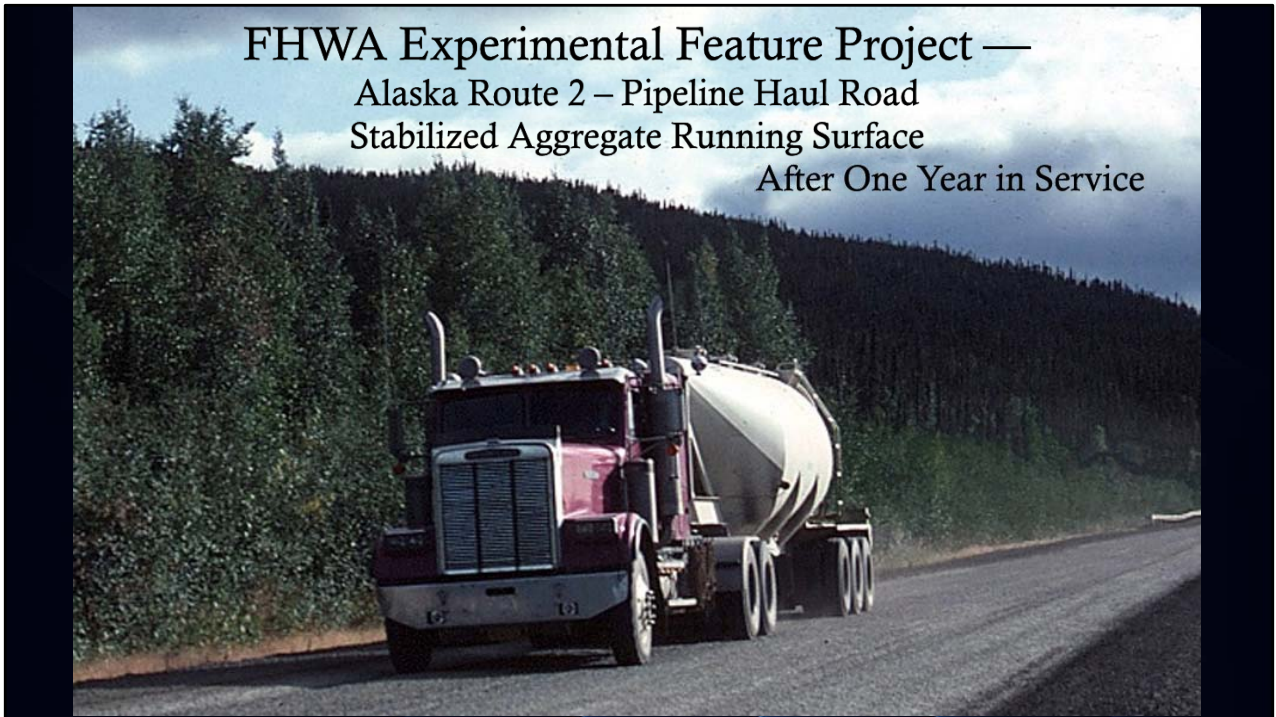
**HAUL TRUCK DRIVING ON STRAIGHTAWAY SURFACED WITH
EMC SQUARED STABILIZED AGGREGATE MATERIAL**

View of haul truck driving on section of stabilized surfacing

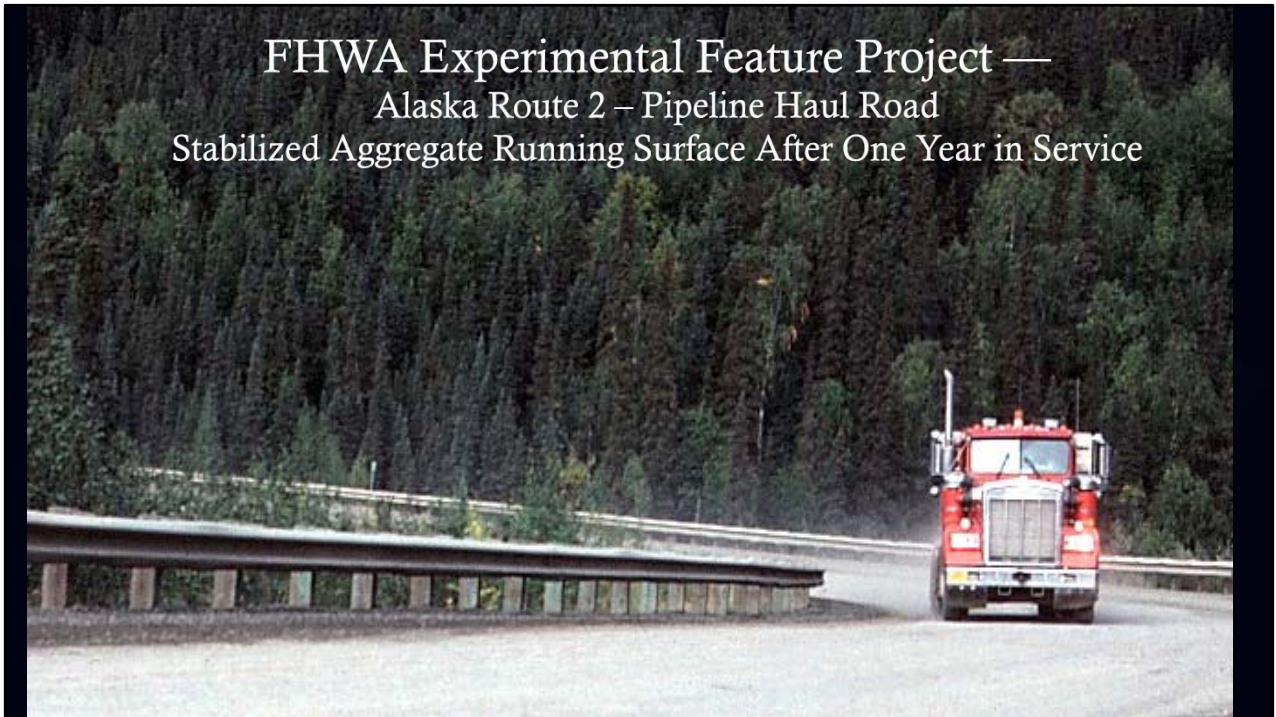
**HAUL TRUCK CORNERING THROUGH SUPERELEVATED CURVE SURFACED WITH
EMC SQUARED STABILIZED AGGREGATE MATERIAL**

View of haul truck cornering through superelevated curve with minimal dusting from stabilized gravel surfacing

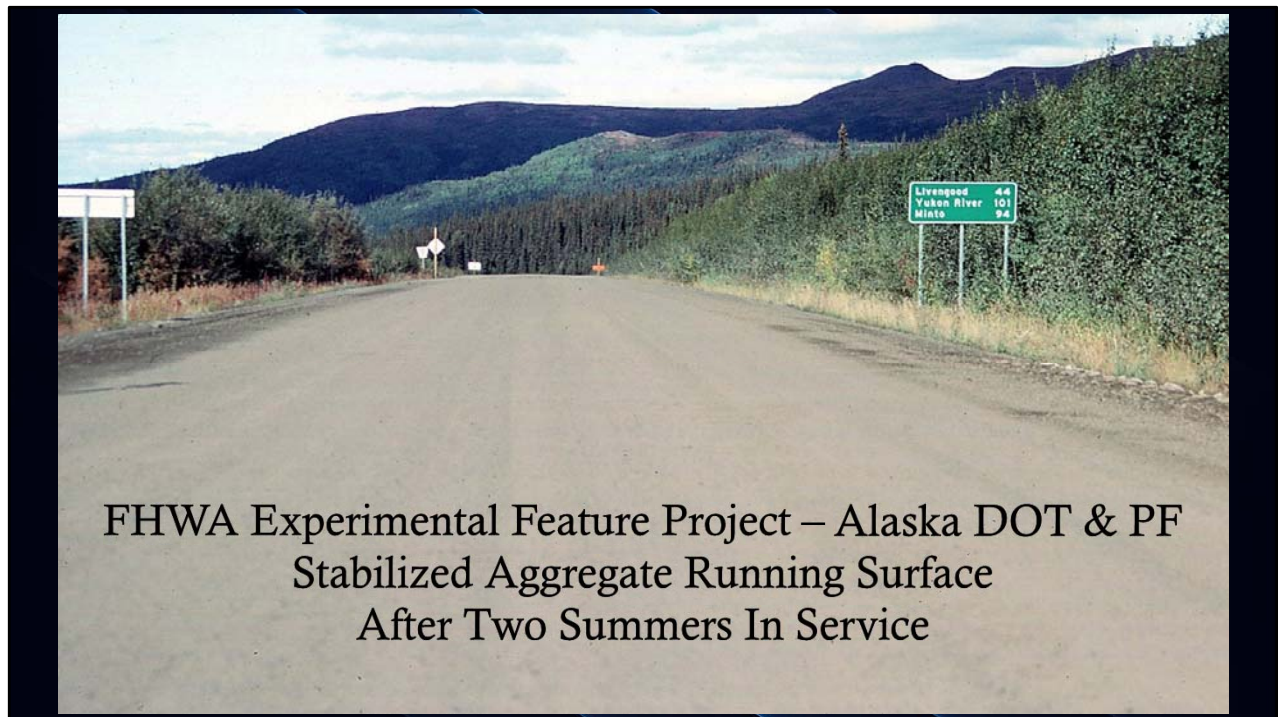
STABILIZED AGGREGATE SURFACING AFTER TWO SUMMERS IN SERVICE

Keeping in mind that this road remains frozen and often covered by snow for half of the year, state engineers noted that the stabilized gravel surfacing provided dust control as effectively as the calcium chloride dust palliative for two full summers as well as excellent road surface stability. The stabilization treatment produced an impermeable, water-shedding running surface that remained virtually maintenance-free for several years.

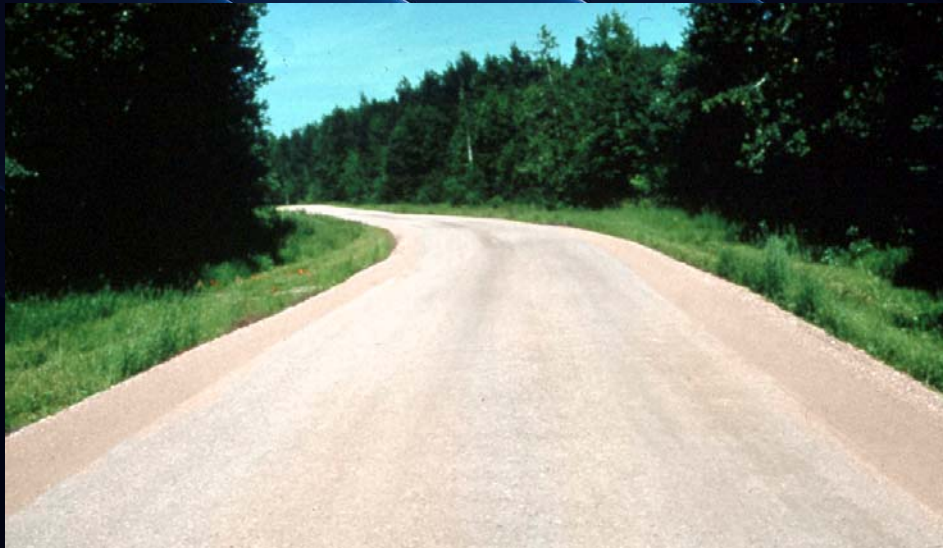
LAKE OF THE WOODS COUNTY, MINNESOTA

With a reported 8.6–day grading frequency being experienced on the gravel surfaced road systems throughout the State of Minnesota, the Local Roads Research Board of Minnesota used FHWA funding to upgrade over six miles of road as part of a research project, working in cooperation with Lake of the Wood County. The road improvement contract for North Angle Road included application of EMC SQUARED stabilizer treatment to three inches of newly placed pit-run gravel followed by an application of calcium chloride dust palliative treatment. The calcium chloride dust palliative was then continued on an annual basis each summer. At last report from the County Engineer, 13 Years after construction, the stabilized gravel running surface treated with the dust palliative remained essentially maintenance free and no longer subject to the freeze-thaw boils that were wide-spread each spring thaw season prior to the road upgrade project. Click on the link below for more information about this road improvement project and the unique area where it is located.

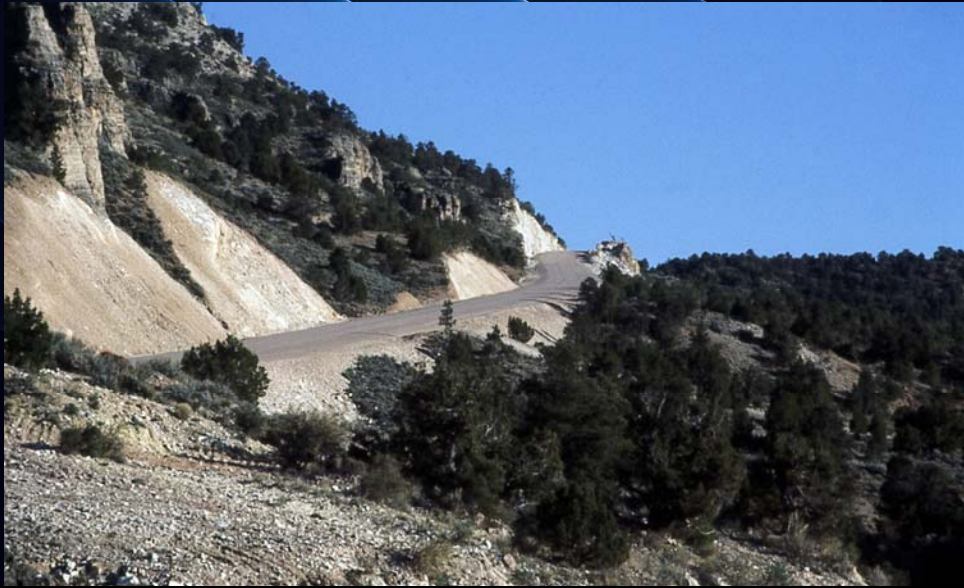
BUREAU OF LAND MANAGEMENT - QUAIL HILL ROAD, NORTHERN ARIZONA

The Bureau of Land Management solved a maintenance problem on a section of aggregate surfaced road that was remote from their District Office and equipment yard. With winding roads and grades as steep as 10%, they used EMC SQUARED Stabilizer products to armor the stabilized aggregate running surface. The BLM Road Engineer reported 14 years later that the stabilized surfacing on this road accessing the North Rim of the Grand Canyon was still providing all-weather service, even on the steep grades and through low water crossings. The same BLM maintenance crew also used EMC SQUARED stabilization treatment to upgrade dirt roads and a dirt runway accessed by the roads with the stabilized aggregate surfacing.

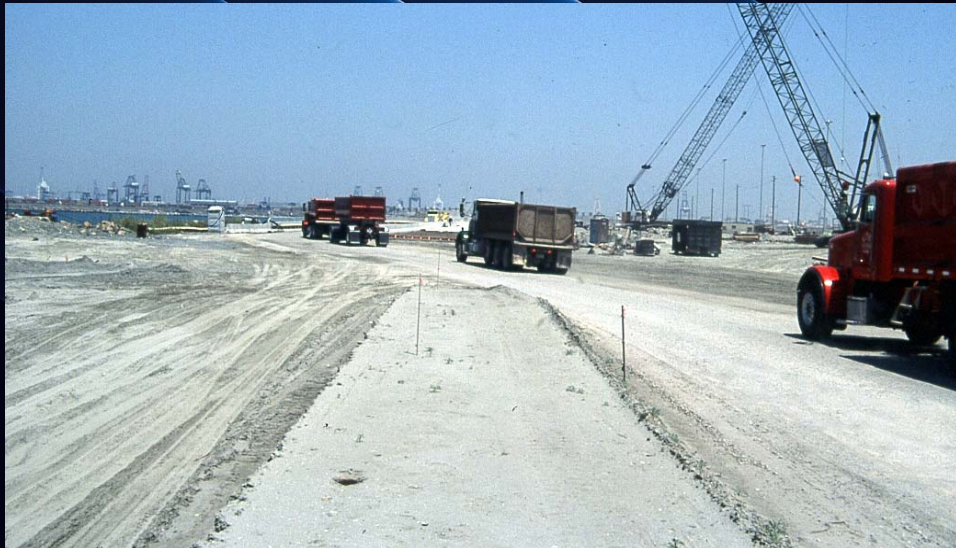
PORT OF LOS ANGELES – ENVIRONMENTALLY FRIENDLY PRODUCTS REQUIRED

This EMC SQUARED Stabilizer was approved by the US Fish & Wildlife Service as environmentally acceptable for construction of a haul road accessing a huge new man-made island that was temporarily being used as a nesting ground by a colony of Least Terns, which are an Endangered Species. The EMC SQUARED Stabilizer products have been tested and approved for use in environmentally sensitive riparian and coastal estuary locations as part of a field-testing program conducted by the U.S. EPA's National Estuary Program.

The maintenance-free performance of this EMC SQUARED application under high frequency haul truck traffic is noteworthy as it functioned as the running surface for two full years before being overlaid with asphalt pavement.

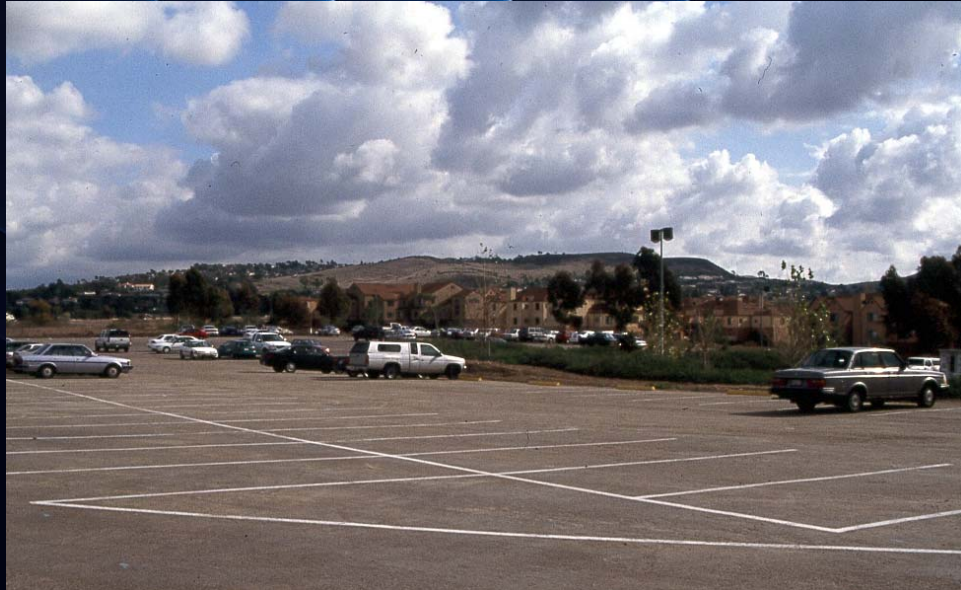
UNIVERSITY OF CALIFORNIA AT IRVINE – ENVIRONMENTALLY FRIENDLY PRODUCTS REQUIRED

The facility engineering staff at the University of California built a 5-acre student parking lot using a recycled aggregate treated with EMC SQUARED stabilizer. To provide effective dust control and a finished surface that would be appropriate for painting parking stall lines, the surface of the EMC SQUARED Stabilized Aggregate layer was treated with a spray-applied polymer emulsion. This temporary pavement pictured here provided five years of maintenance-free service before being swept and overlaid with a hot mix asphalt pavement surface course. The stabilizer products in this case met State of California approval for a project with natural drainage into a protected area of the Upper Newport Bay coastal estuary.

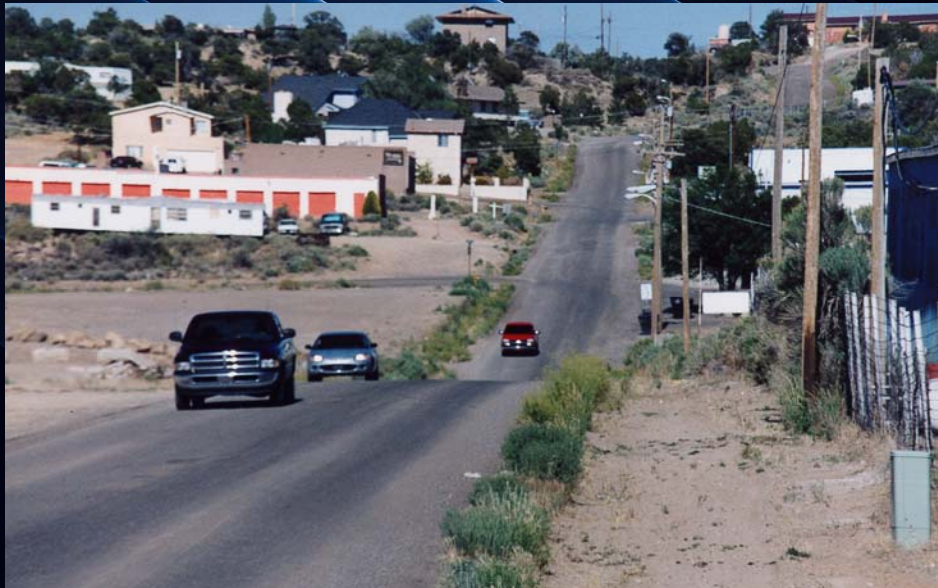
CITY OF GALLUP, NEW MEXICO – STABILIZED ASPHALT MILLINGS STREET SURFACING

Maintenance-free for five years, these streets paved with EMC SQUARED Stabilized Asphalt were then broomed and overlaid with hot mix asphalt pavement when the funds finally became available.

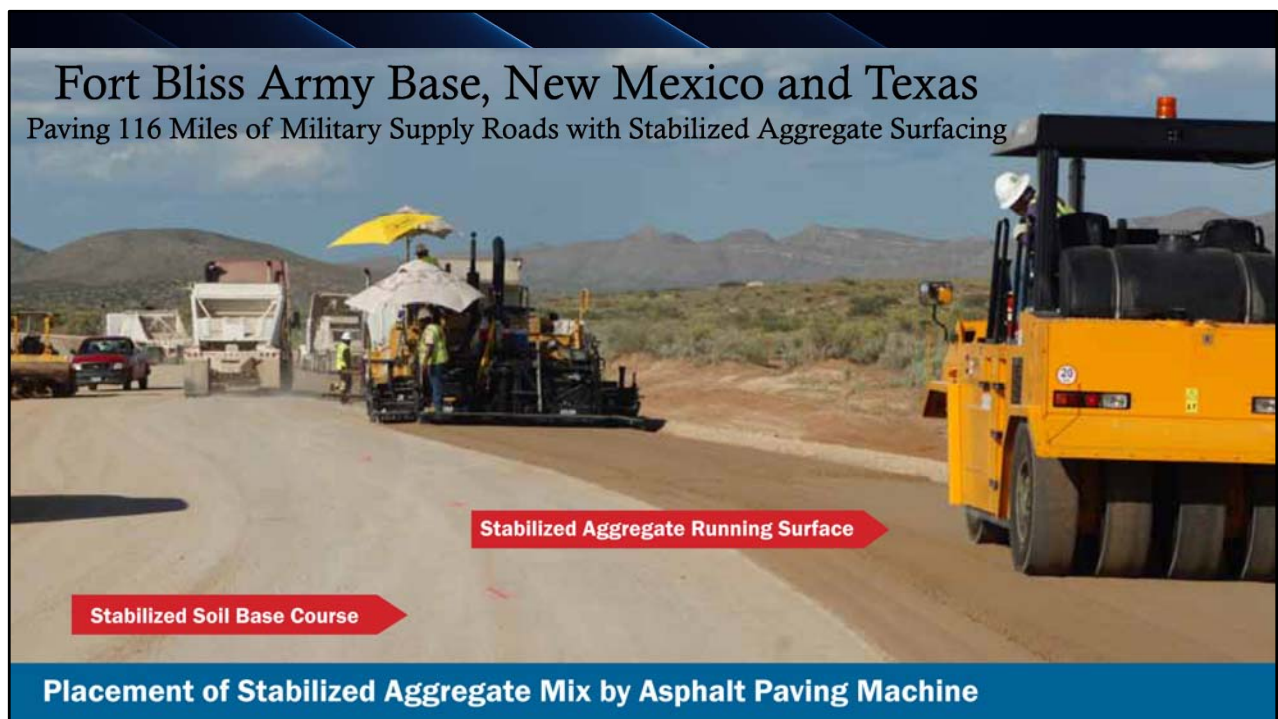
FORT BLISS ARMY BASE - PAVING MACHINE PLACEMENT OF STABILIZED AGGREGATE SURFACING

Fort Bliss spans the states of New Mexico and Texas. 116 miles of Main Supply Routes (MSR's) were upgraded with a running surface constructed with EMC SQUARED Stabilized Aggregate. Over a decade later the stabilized aggregate surfacing produces only a minimal amount of dusting under the traffic of military tactical equipment while the network of untreated gravel roads at Fort Bliss still suffer high rates of gravel loss and large billowing clouds of dust emissions. The aggregate materials were treated with the EMC SQUARED stabilizer at a stationary pugmill mixing plant located near the gravel pit and rock crushing plant, trucked in bottom dump trucks and placed by a combination of pick up machines and asphalt paving machines.

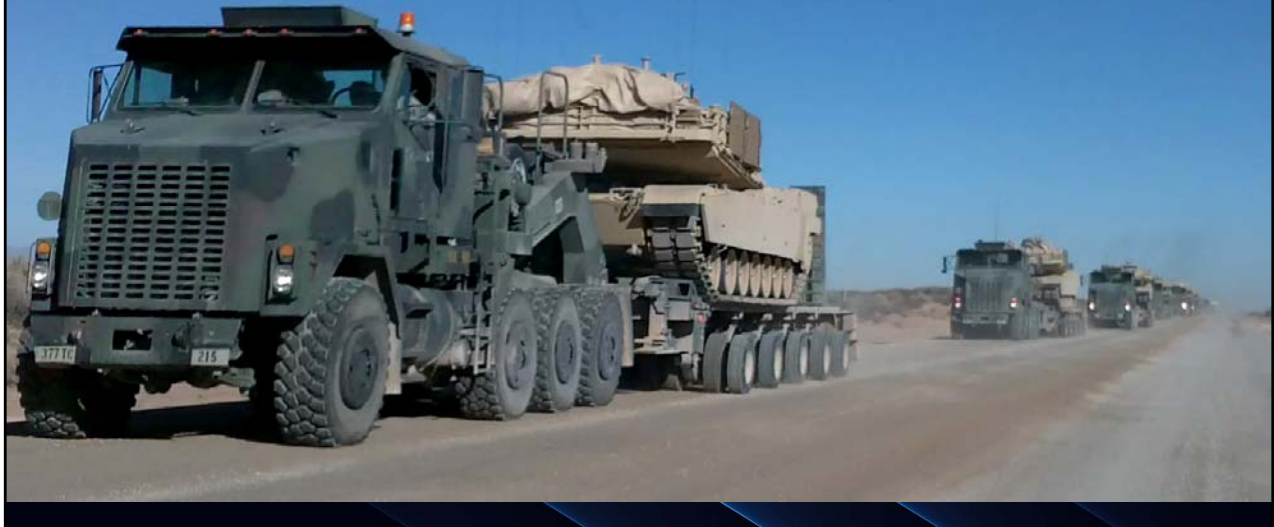
FORT BLISS ARMY BASE – CONVOY OF TRANSPORT TRUCKS ON EMC SQUARED STABILIZED AGGREGATE ROAD

Pictured here is a fleet of the transport trucks moving battle tanks on a lane of recently placed stabilized aggregate. Next to this lane of cured stabilized aggregate is a lane of stabilized aggregate that was placed the previous day. EMC SQUARED Stabilized Aggregate surfacing can typically support heavy truck traffic with minimal curing time required.

More than ten years after the placement of this stabilized aggregate surface course it is still functioning as a low-dust running surface. This is in direct contrast to the aggregate roads that have not been stabilized and roads that were once treated with a dust palliative. The difference between the short lifespan of a dust palliative application and the extended service life of an EMC SQUARED Stabilized Aggregate surface course being the fact that the stabilizer improves the full depth of the treated aggregate layer. The wearing action of traffic is resisted through the full depth of the uniformly stabilized layer.

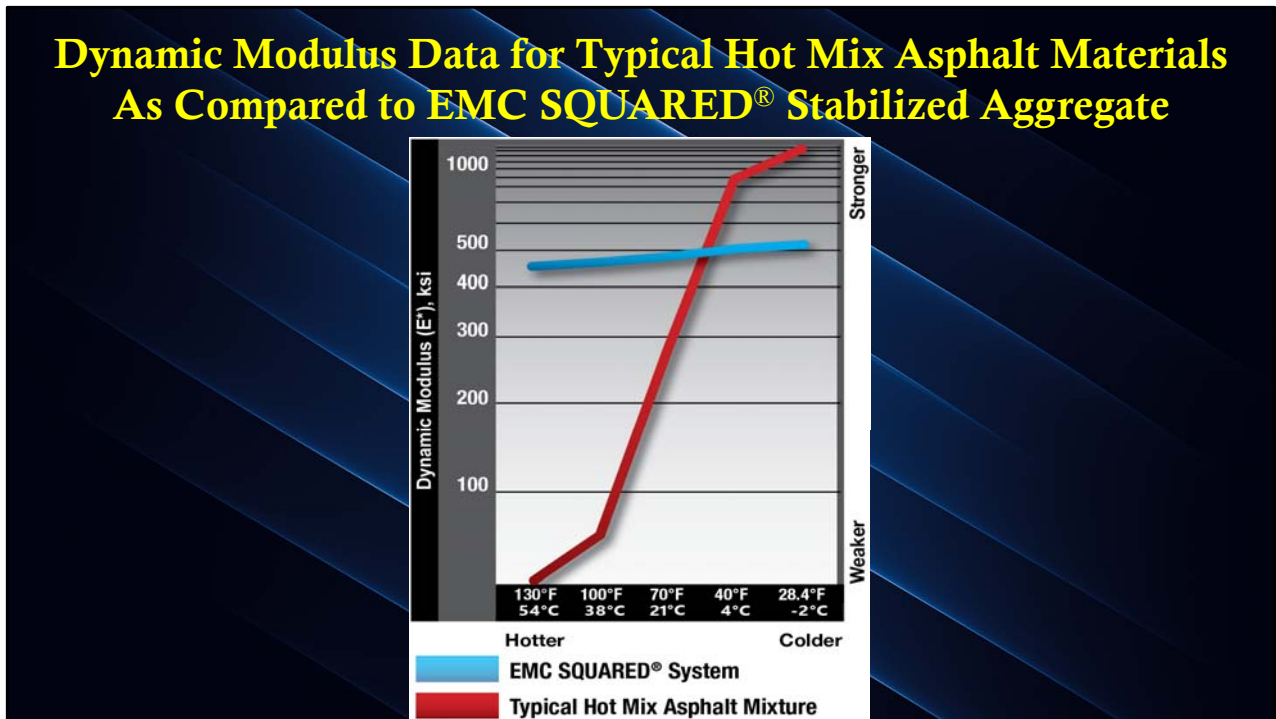
Dynamic Modulus Data for Typical Hot Mix Asphalt Materials As Compared to EMC SQUARED® Stabilized Aggregate

TEST RESULTS FROM THE ASPHALT PAVEMENT MATERIALS TESTING LAB AT THE WESTERN REGIONAL SUPERPAVE CENTER (WRSC) WHERE FHWA RESEARCH STUDIES ARE CONDUCTED – DYNAMIC MODULUS TEST RESULTS SHOWN HERE

This comparison with Hot Mix Asphalt (HMA) materials is highly favorable to the EMC SQUARED Stabilized Aggregate Material. For a report on this Dynamic Modulus testing, click on the link below.

In contrast to cement treated aggregate materials that exhibit slab-like, or rigid behavior, EMC SQUARED Stabilized Aggregate materials retain elastic, or flexible behavior, more similar to asphalt pavement mixtures. HMA pavement mixtures happen to be viscoelastic in nature, meaning that they weaken as temperatures get hotter and/or as loads get heavier. Their behavior is constantly changing in response to variations in temperature and loading conditions. Therefore, a direct comparison of EMC SQUARED Stabilized Aggregate with asphalt mixtures requires use of the Dynamic Modulus test method, since it is capable of evaluating performance under different temperature and loading conditions. As illustrated here, the EMC SQUARED Stabilized Aggregate has consistent high modulus value while the asphalt pavement mixture is dramatically weakened as temperatures or load weights are increased.

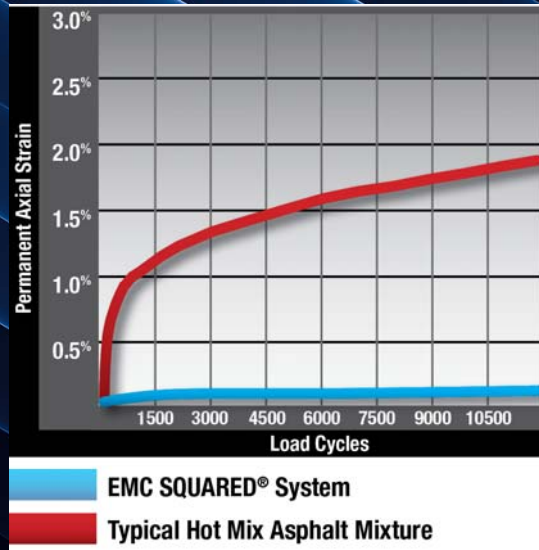
Permanent Deformation Curves for Typical Hot Mix Asphalt Materials and EMC SQUARED® Stabilized Aggregate

TEST RESULTS FROM THE ASPHALT PAVEMENT MATERIALS TESTING LAB AT THE WESTERN REGIONAL SUPERPAVE CENTER (WRSC) WHERE FHWA RESEARCH STUDIES ARE CONDUCTED – REPEATED LOAD TRIAXIAL (RLT) TEST RESULTS SHOWN HERE

This test illustrates the fact that the EMC SQUARED Stabilized Aggregate material is capable of supporting heavy loads that would permanently deform asphalt pavement. Full report on this Repeated Load Triaxial testing is provided. Take a few minutes and go down this revealing Rabbit Hole.
